ARBORIST REPORT
For
24th St SE Extension – Lake Stevens
H.W. Lochner, Inc
Lake Stevens, WA

November 1st, 2017

H W Lochner Lake Stevens - Significant Tree Study

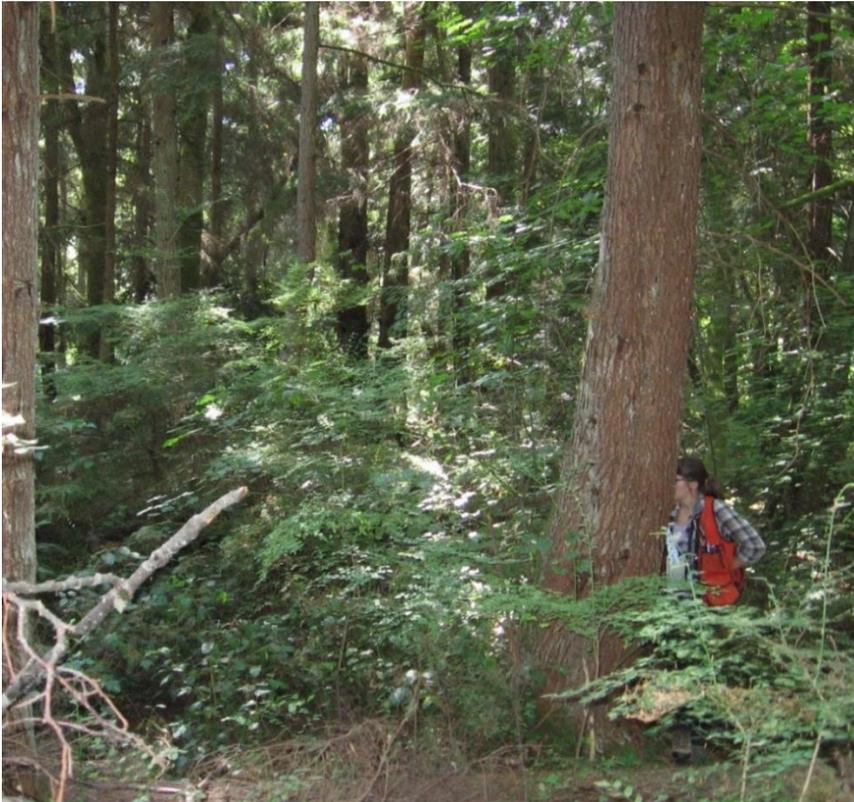
Subject area with moderate understory

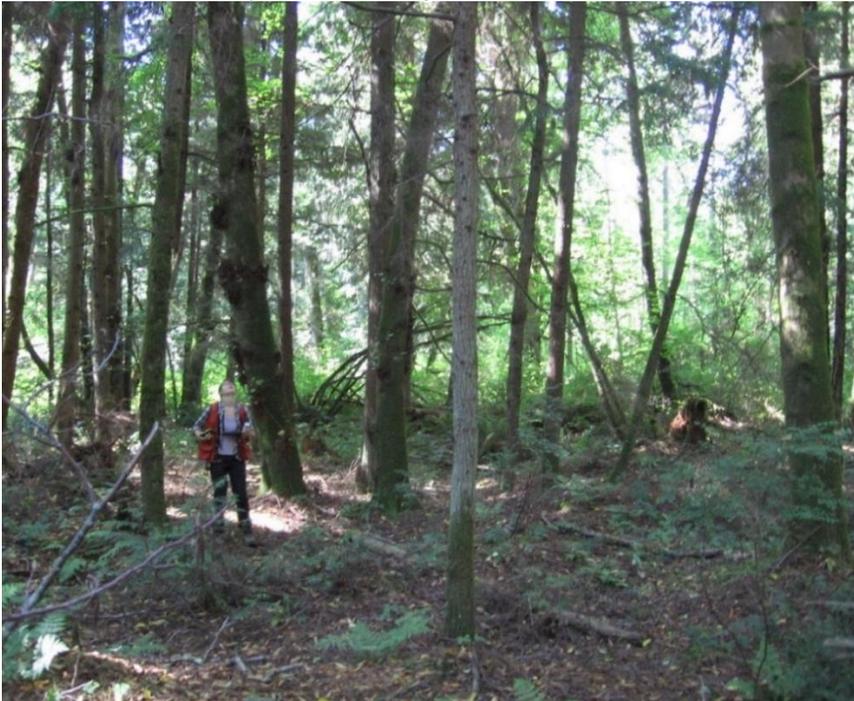
Subject area with open understory

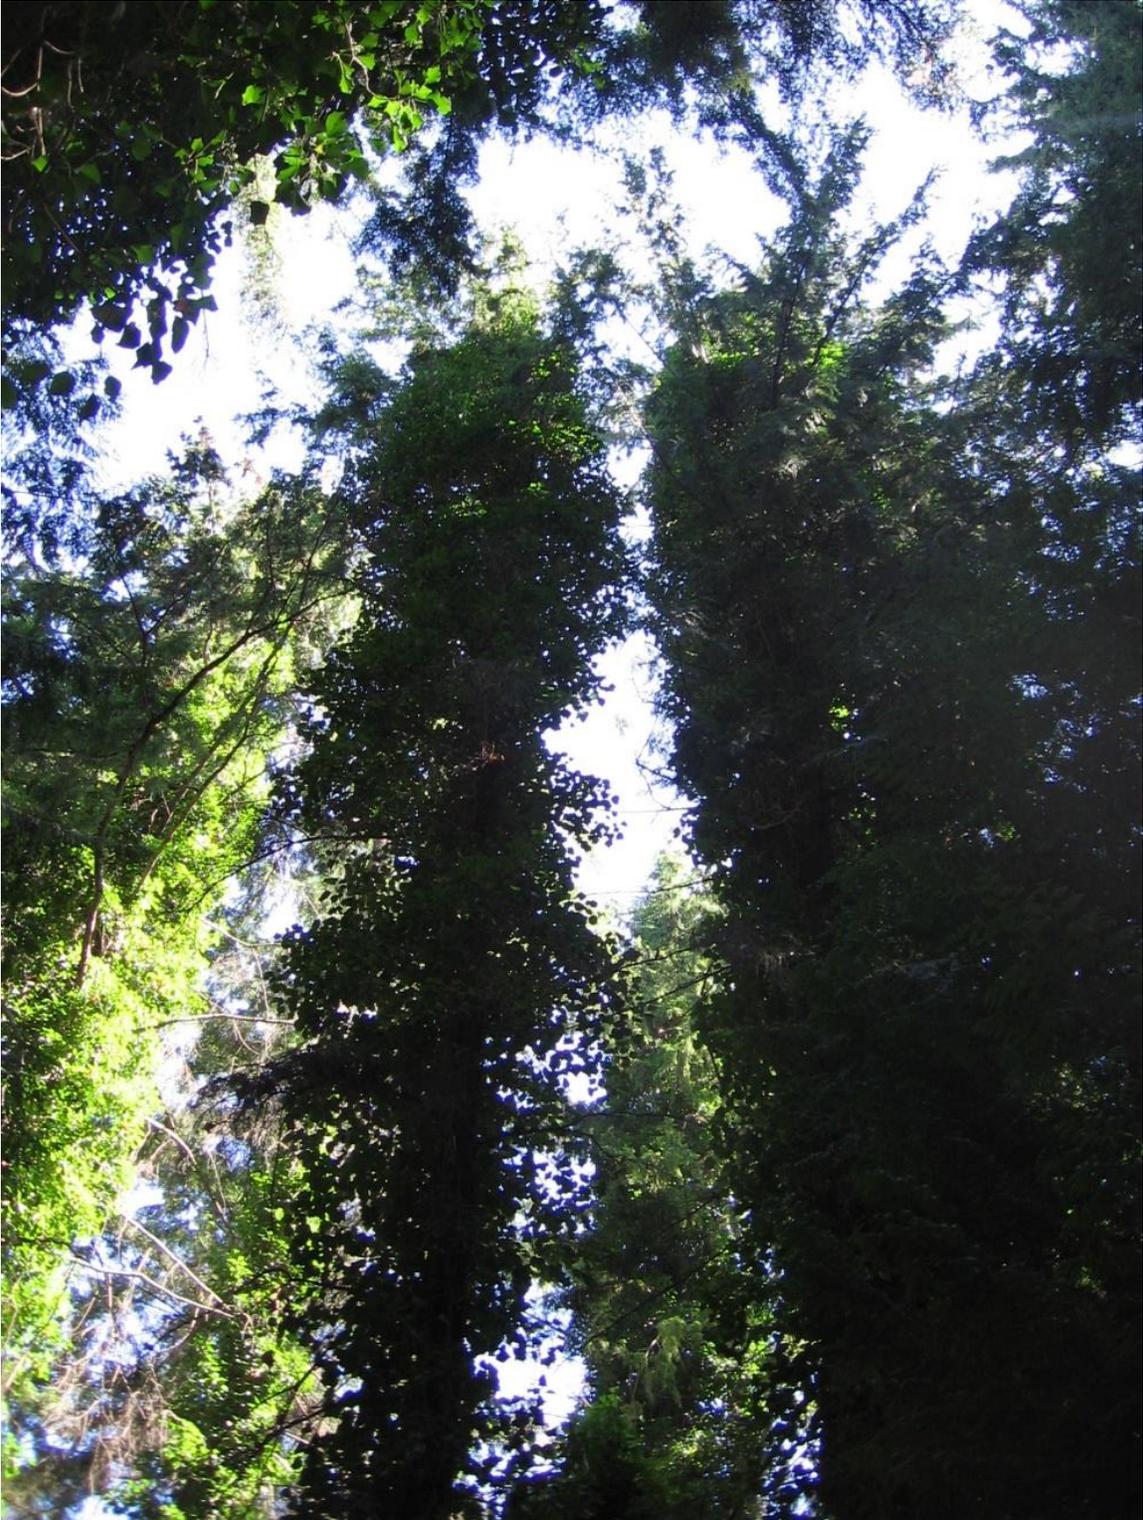
The ages of the hemlocks and cedars varied greatly with a range of diameters from 10" to 67". Cedars appeared healthier and 69% were categorized in good condition compared to 57% of hemlocks. Structural defects in hemlocks consisted of codominant stems, natural leans, and stilted roots. Stilted roots, a result of a seedling growing on a stump or log that eventually decays to leave the mature tree elevated and supported by several 'stilts', may not necessarily increase the likelihood of tree failure by itself¹. Some recently fallen trees had normal trunks and root crowns intact. Most trees in the NW area of the property along the proposed extension of 91st Ave SE as it approaches 20th St SE had ivy growing on the trunk or into the canopy.

Western hemlock in northwest section with ivy

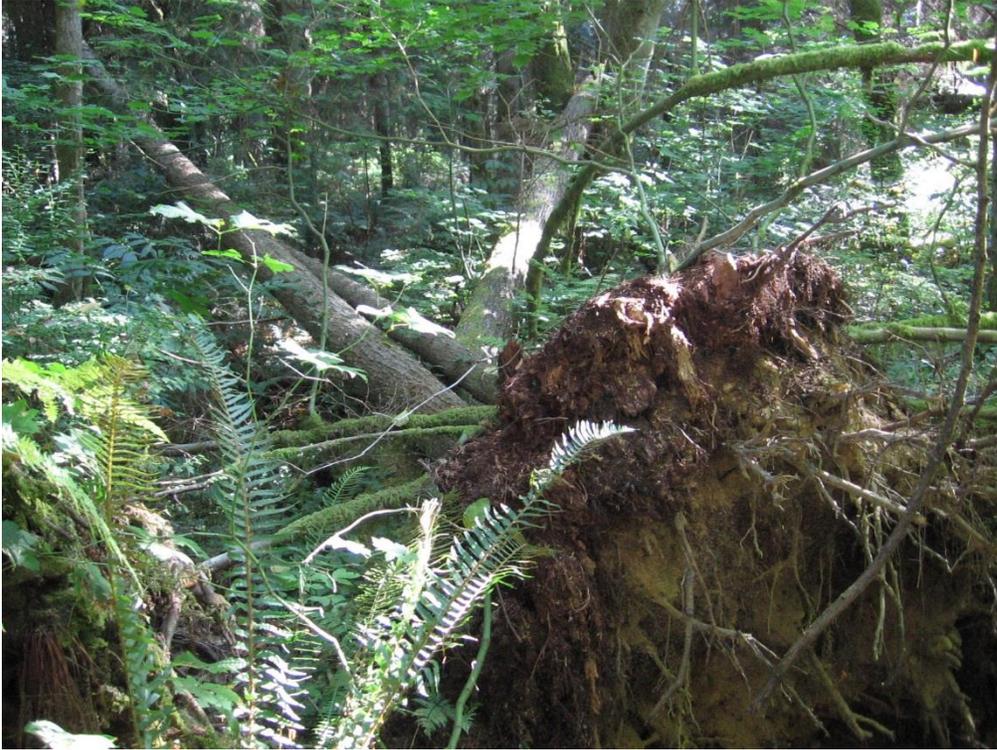
Blowdown with exposed root crown

Development edge areas should be assessed after the initial clearing to identify and remove any high-risk or hazard trees leaning towards the proposed improvements or that may have been compromised during clearing activities.

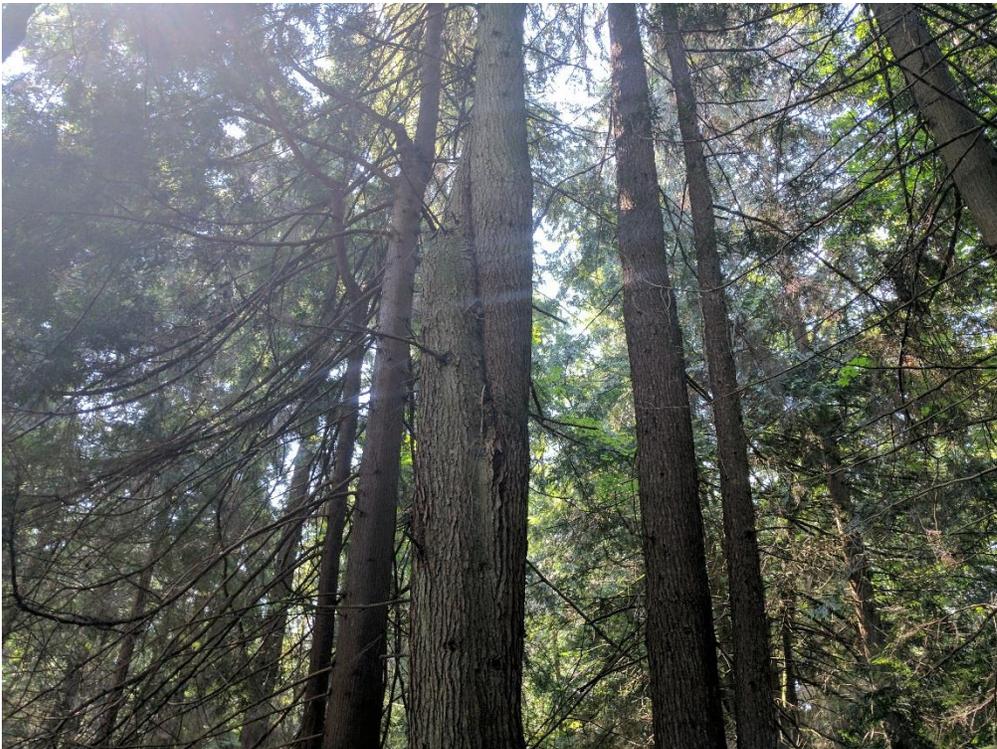
Western hemlock with codominant stems

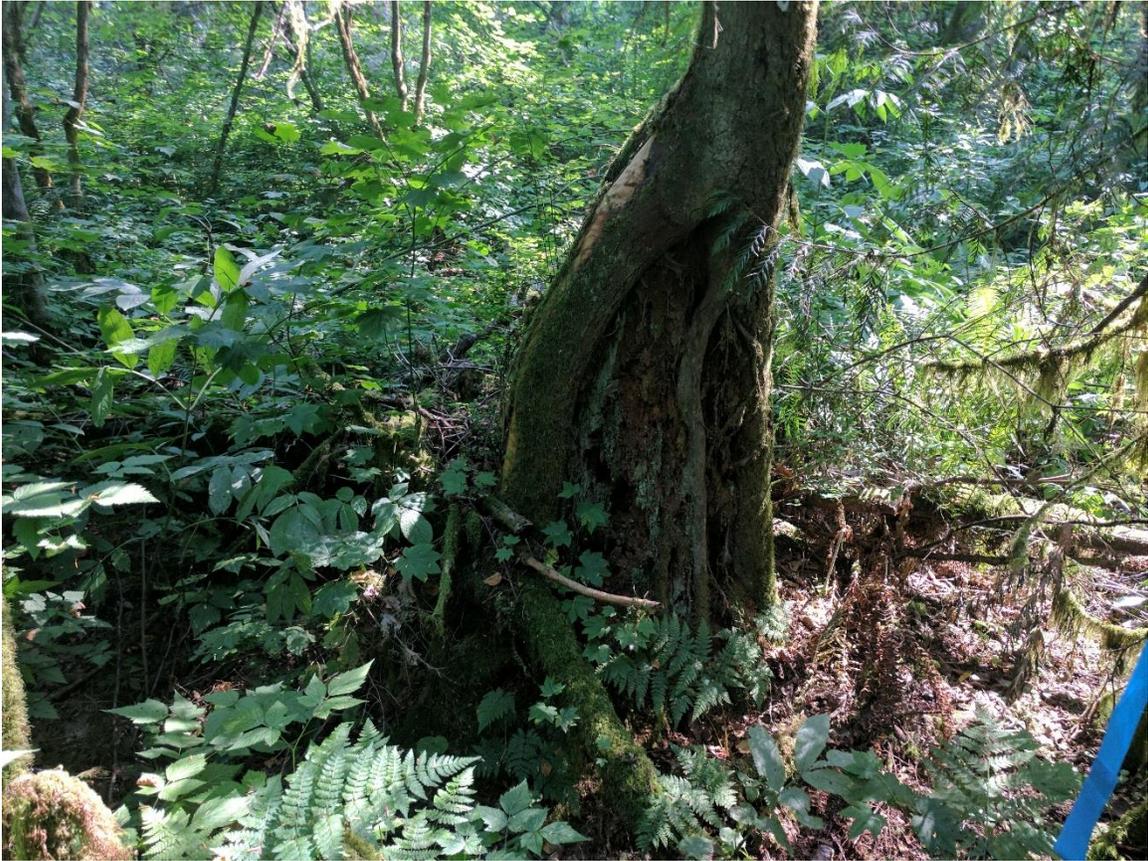
Western hemlock with stilted roots
